Protect Your Home, Family, Pets & The Environment

B139 Series-15: Installation Code For Oil-Burning Equipment

Install a New Epoxy-Coated Oil Filter or Filter Bowl Kit Today!

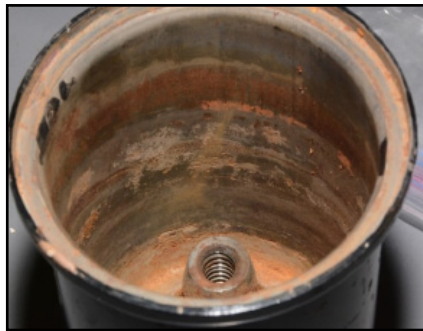
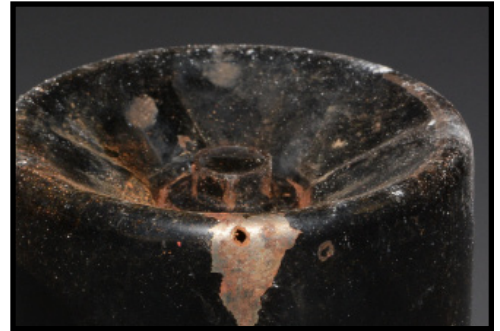
If You See This:

- Rust or Corrosion
- Hole In Bottom of Can
- Rust on outside of can

If any of the defects listed above, or any other defect is found:

We recommend replacement of any pre-2009 galvanized filter bowls with newer epoxy coated version introduced in 2009

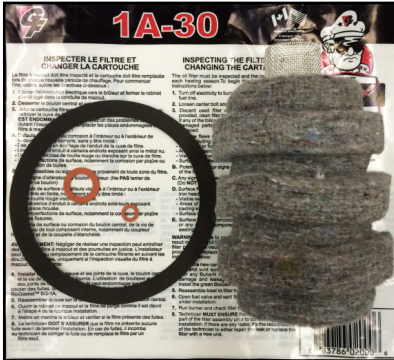
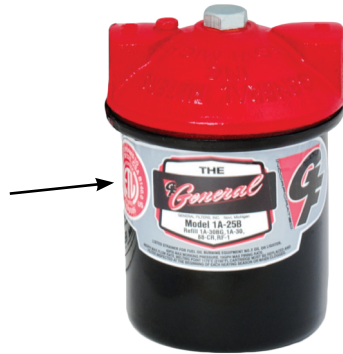
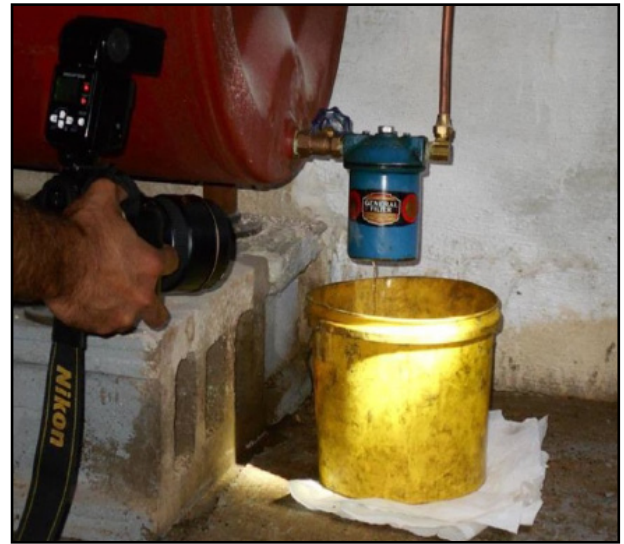
This Could Have Been Avoided.

This oil leak resulted in a house being bulldozed, and the home owner filing a \$1,000,000 claim; all because the technician put in a competitor's replacement filter that pinched the gasket and created a leak.

Use Only General Filters Approved Products
